**Flood Control Project Maintenance
Levee Inspections**

Maintenance Issue Types Only, Levee Inspection Report By Mile - Spring 2019

Reclamation District No. 2094 Walthall

Waterway	Bank	Unit Miles	Inspection Start/End	Inspector
Unit No. 01 San Joaquin River	Right	2.78	05/01/2019 05/01/2019	Alberto De Leon

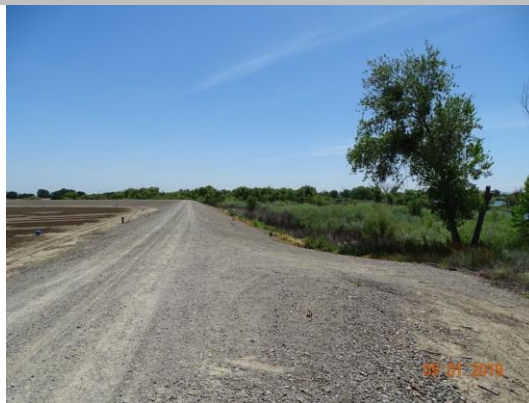
Photo 1 of 1 : SP_2019_RD2094_320_7_20190514_00015.jpg

LM Start	0.28	Rating **	A	Issue No.	7
LM End	2.78	Issue Type +	Ma	Location *	WS
Category	Earthen Levee			GPS Latitude/Longitude	
				Start	End
Item	Vegetation			37.769280 °	37.749548 °
				-121.300827 °	-121.288901 °
DWR ID	DWR_RD2094_01_s_2019_7				
Comment Code					
V1 : Control annual grass and weeds on the levee slopes and easements.					
Inspector Comment					
Annual vegetation is well maintained.

Typical view of vegetation on waterside slope. (Spring 2019)

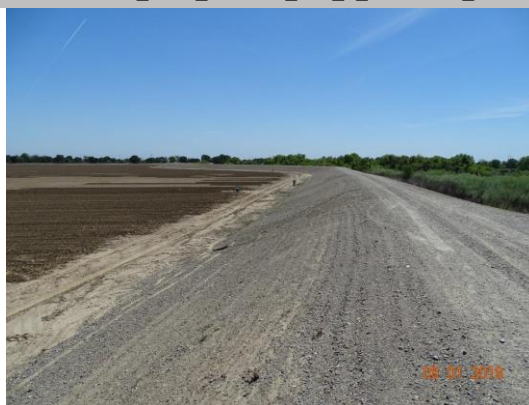
Photo 1 of 1 : SP_2019_RD2094_320_6_20190514_00016.jpg

LM Start	0.28	Rating **	A	Issue No.	6
LM End	2.78	Issue Type +	Ma	Location *	LS
Category	Earthen Levee			GPS Latitude/Longitude	
				Start	End
Item	Vegetation			37.769278 °	37.749548 °
				-121.300824 °	-121.288901 °
DWR ID	DWR_RD2094_01_s_2019_6				
Comment Code					
V1 : Control annual grass and weeds on the levee slopes and easements.					
Inspector Comment					
Annual vegetation is well maintained.

Typical view of vegetation on landside slope. (Spring 2019)

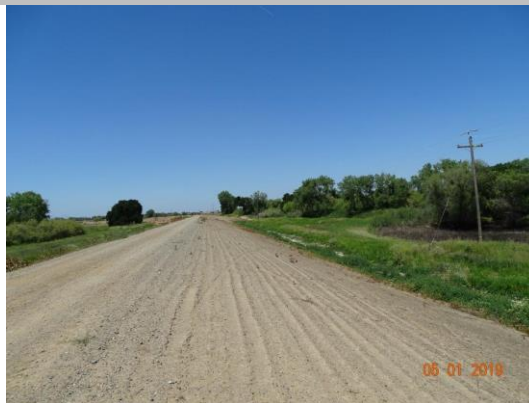
Photo 1 of 1 : SP_2019_RD2094_321_1_20190514_00001.jpg

LM Start	0.06	Rating **	A	Issue No.	1
LM End	0.45	Issue Type +	Ma	Location *	WS
Category	Earthen Levee			GPS Latitude/Longitude	
				Start	End
Item	Vegetation			37.759668 °	37.760587 °
				-121.300474 °	-121.307271 °
DWR ID	DWR_RD2094_02_s_2019_1				
Comment Code					
V1 : Control annual grass and weeds on the levee slopes and easements.					
Inspector Comment					
Annual vegetation is well maintained.

Typical view of vegetation on waterside slope. (Spring 2019)
